A BIG BURST

A pipe-bursting system with a 60-ton ram enables replacement of a hotel's 8-inch, cast-iron sewer lateral

Replace a hotel's 160-foot cast-iron sewer lateral with minimum business disruption

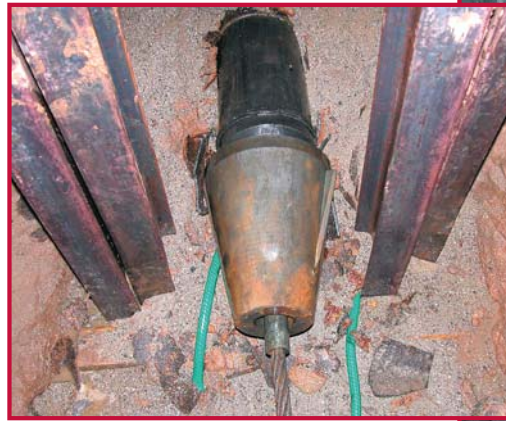
This pulling assembly was used to burst the old pipe.

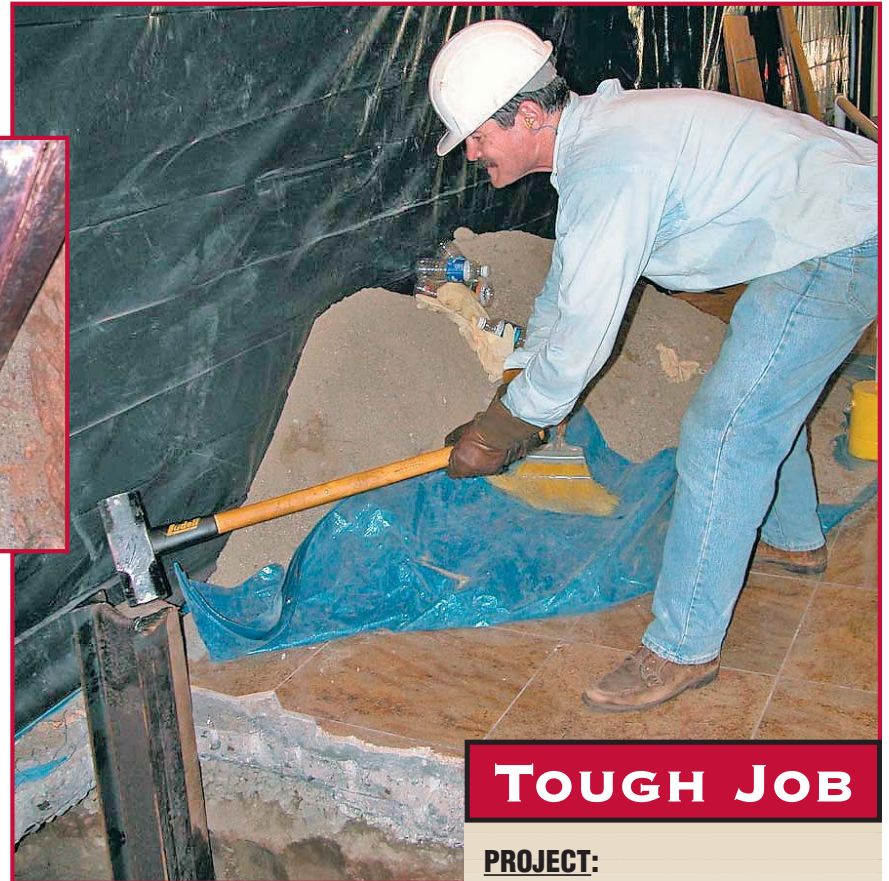
A technician drives in an I-beam as part of the foundation for the pull.

Sand was piled in the hallway. Using sledgehammers, they drove two 6-inch I-beams four feet into the ground to shore up the hole. Wood beams, 6- by 6-inch, spanned the steel and received the resistance plate, giving a solid foundation against which to pull.

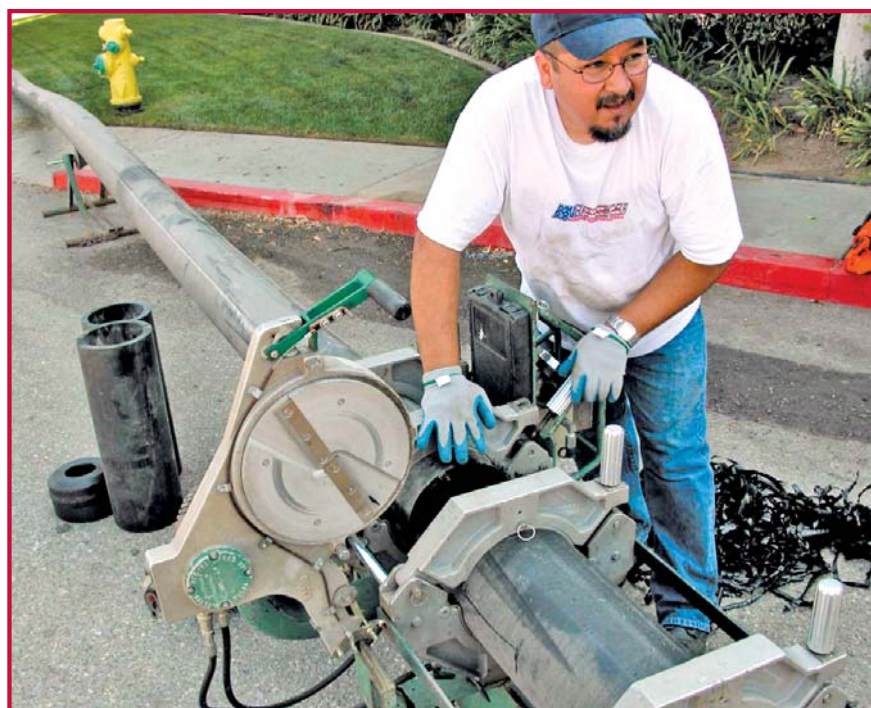
A technician fuses sections of 8-inch SDR17 HDPE pipe.

"We couldn't get large equipment inside the hotel. Everything had to be carried in by hand," says Ramsey. John Rafferty and his TRIC team arrived Tuesday to fuse 200 feet of 8-inch SDR17 high-density polyethylene pipe. It lay alongside the sidewalk while prepara-

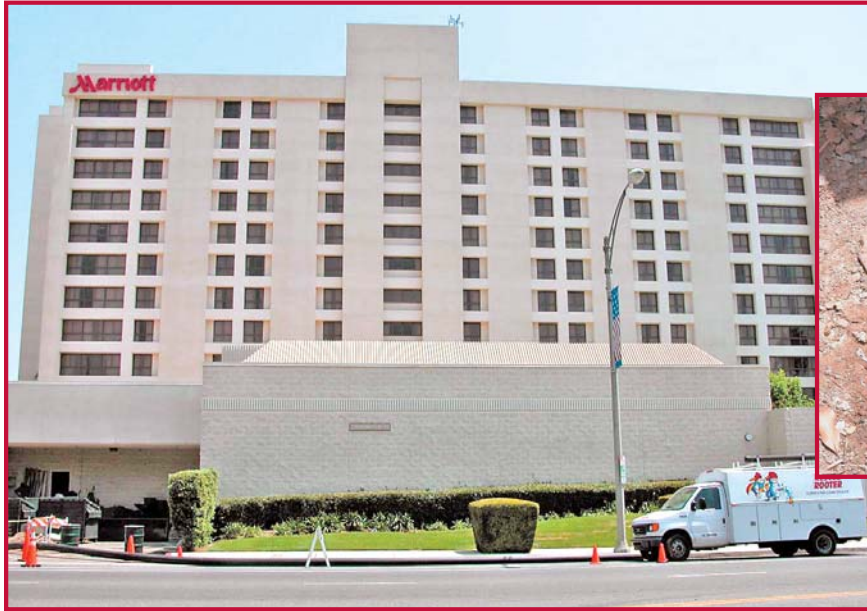
The camera, often underwater, revealed erratic but heavy corrosion, a rotted invert near the street, and too much collapsed pipe to warrant relining. The decision was made to replace the entire 160-foot line from its connection point with the municipal sewer.

At left, the Riverside Marriott Hotel. Below, a section of the corroded pipe.
