Flirting with Failure

A PREVIOUSLY UNTESTED SWAGED SPLITTER ENABLES A CONTRACTOR TO REPLACE A RESIDENTIAL WATERLINE IN NORTHERN CALIFORNIA

PROJECT: Replace a leaking 1-inch waterline in a landscaped yard

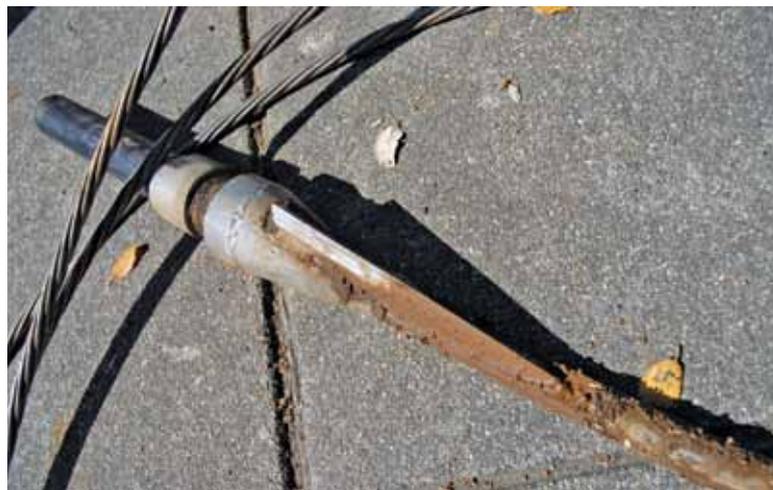
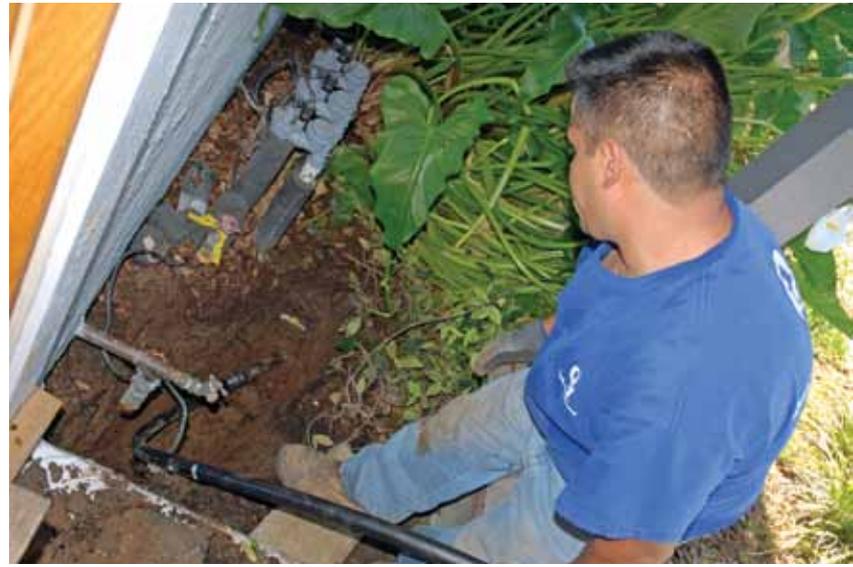
Technician Atanacio Francisco from Quality First Plumbing helps guide the 1-inch HDPE replacement pipe into the pit at the start of the pull. The ACME coupling attaching the pipe to the rear of the bursting head is visible just past the spigot. (Photos courtesy of TRIC Tools)

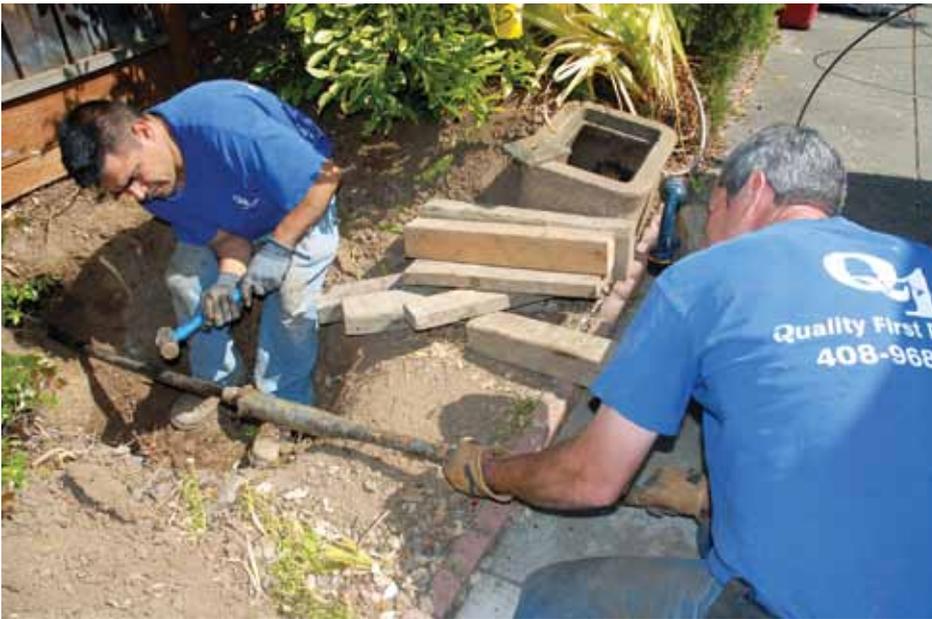
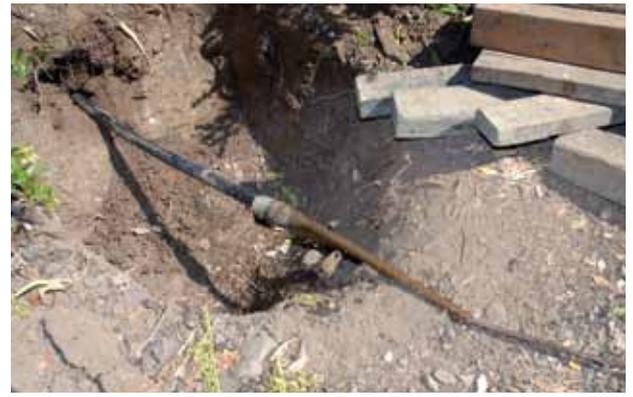
The bursting head and slitting blade after the pull. The head is flat on the bottom with the blade above it.

LEFT: Atanacio Francisco hammers the last length of galvanized pipe off the bursting head as Bob Zamaroni hangs on and pulls. The stop plate is on top of the utility box. RIGHT: Pull completed. A 2-inch-long Acme screw adaptor attaches the 1-inch HPDE pipe behind the 16-inch-long bursting head with 6-inch-long slitting blade welded at rear. Note the 2-degree bend in the cable at the swage and the length of the swage before it reaches the inverted slitting blade.

The team dismantled the ram, and Zamaroni grabbed the pipe and yanked it out of the hole, bringing the head and HDPE pipe along behind it. Francisco, still standing in the pit, used a 3-pound hammer to knock the pipe off the bursting head while Zamaroni hung on and pulled.

“The cable exhibited a slight helical deformation,” says Rafferty. “Corkscrewing means it was pulled harder than it wanted to be around a tight radius. PTI cable is designed only for direct pulls. We also found a 2-degree bend in the cable at the swage because we pulled the head termination just an inch too far under the wheel. However, the tool proved that it could do the job.” In four hours, the homeowner had a new waterline and his service restored. **C**
