FOCUS: SEWER

GETTING TOUGH ON I&I

The Vallejo Sanitation and Flood Control District uses pipe bursting as a key technology in an aggressive program to tighten its sewers

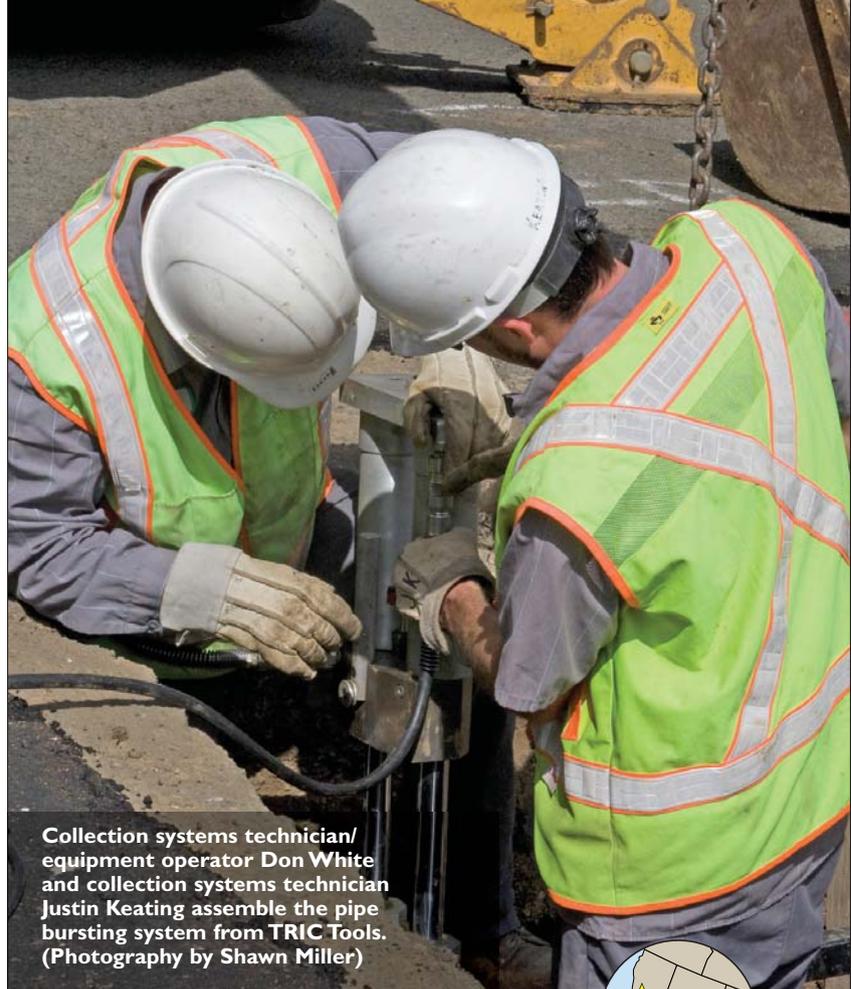
Collection systems technician/equipment operator Don White and collection systems technician Justin Keating assemble the pipe bursting system from TRIC Tools. (Photography by Shawn Miller)

however, used tees at the main-lateral junctions or saddle-fused the connections, and they were tight. At the same time, the 6-inch mains were upsized to the 8-inch industry standard, and that was the pivotal factor in Jannings’ decision to purchase a 30-ton pipe-bursting system from TRIC Tools Inc.

“We had done everything open-cut until then, so excavating two holes and not an entire street made a lot more sense,” says Jannings. “Before long, the real push became to pipe-burst laterals. A three-man crew excavates entrance and pull pits at the main and behind the sidewalk at the district cleanout.

The project blocks only one lane of traffic. It’s completed by the end of the day, and it puts an end to root intrusion. The lines basically become maintenance-free once they’re rehabilitated.”

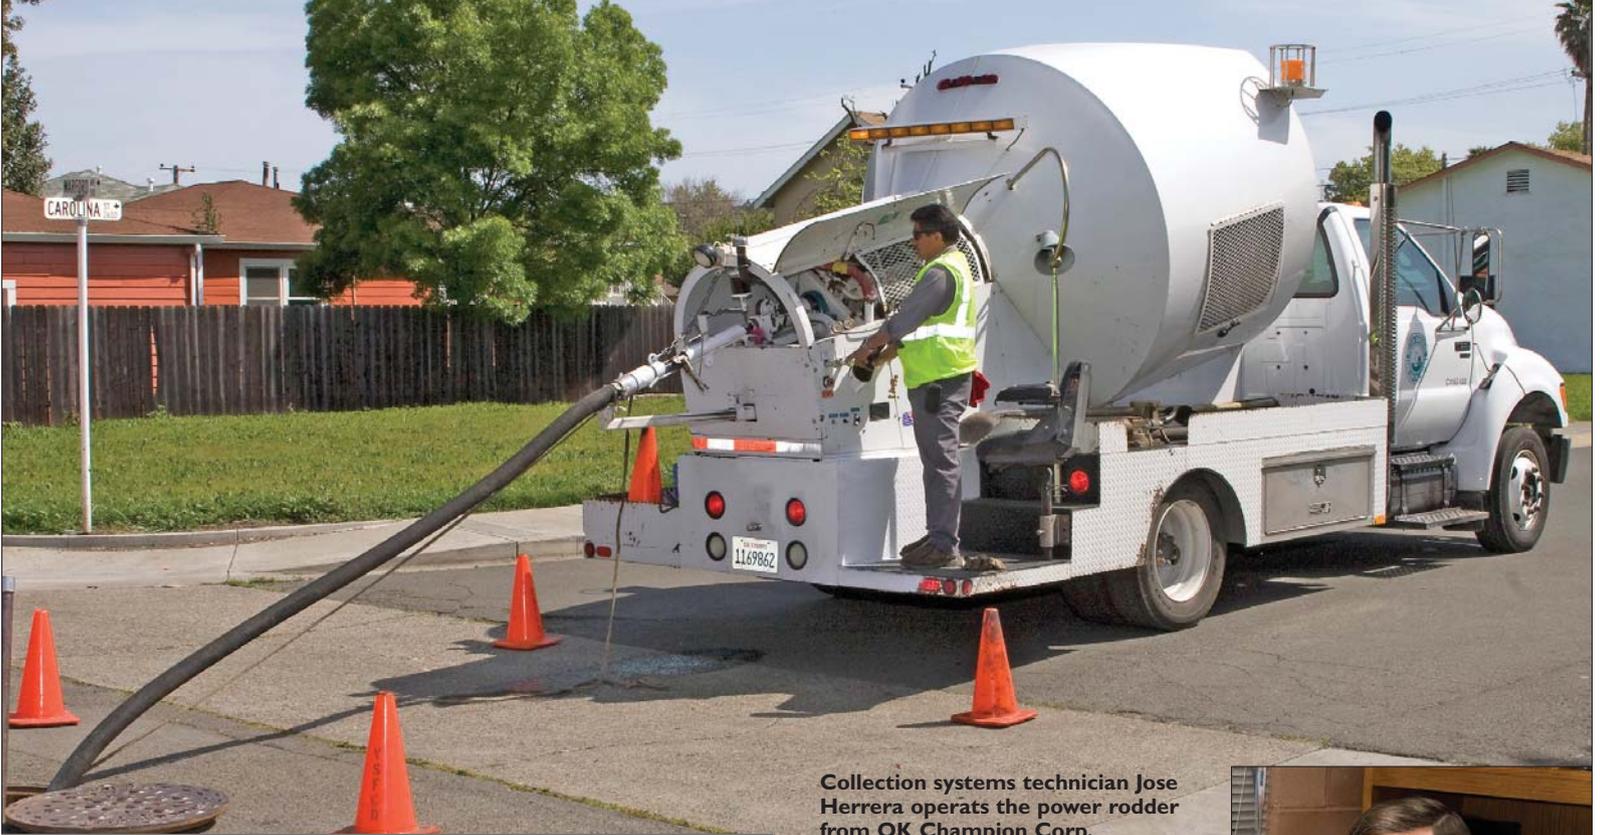
Collection systems technician Jose Herrera operates the power rodder from OK Champion Corp.

The district’s pipe-cleaning program includes jetting, pigging or rodding siphons twice a month to remove the solids that collect on the bottom. The district has two jet trucks: an HV high-pressure unit from SRECO-Flexible and an 800-H unit from Sewer Equipment Co. of America. It also has a truck-mounted continuous rodder from OK Champion Corp.

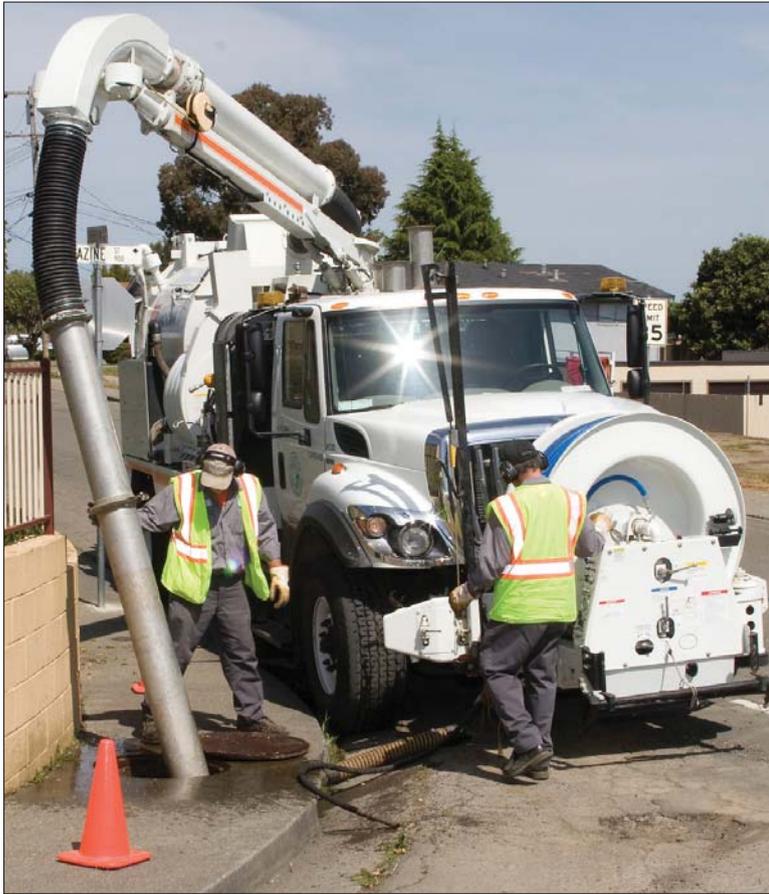
Collection systems technician Denis Crockett cleans a catch basin as collection systems technician Tom Riedl operates the the Vac-Con 1300 combination truck.

The staff sometimes uses a Vac-Con 350 LHA-1000 combination sewer cleaner with hydroexcavator package because the water

tank enables them to jet more lines on one fill up. The truck also has a 5-cubic-yard debris body, 8,000 cfm three-stage fan, and 50 gpm/3,000 psi water system.

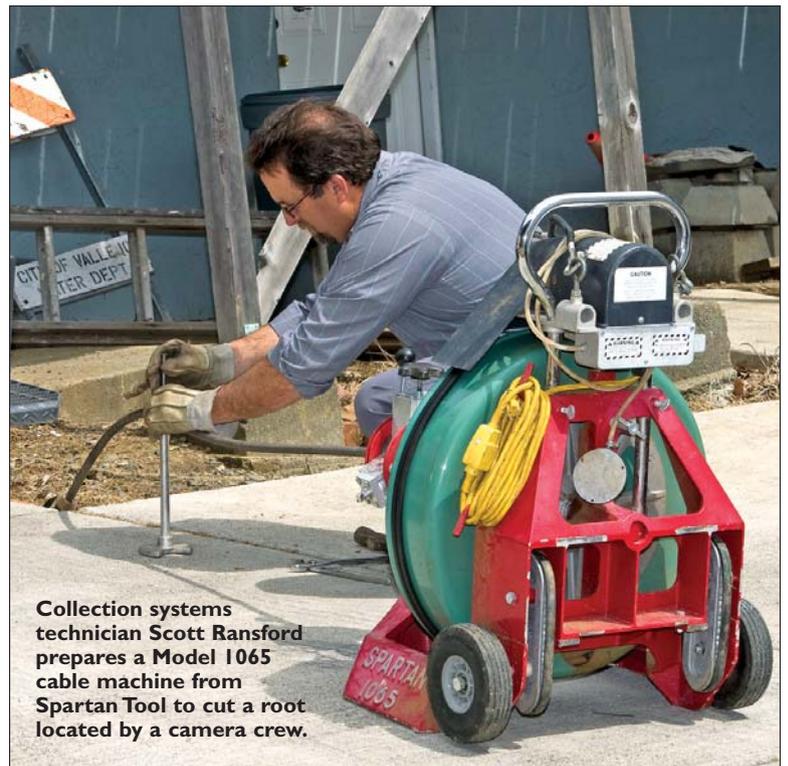
Collection systems technician Scott Ransford prepares a Model 1065 cable machine from Spartan Tool to cut a root located by a camera crew.
